CAD/CAM METHODS IN SUPPORT OF HISTORIC PRESERVATION: A CASE STUDY OF THE FREEMAN HOUSE BY FRANK LLOYD WRIGHT

Douglas Noble, AIA, Ph.D.
University of Southern California
dnoble@usc.edu

Karen M. Kensek
University of Southern California
kensek@usc.edu

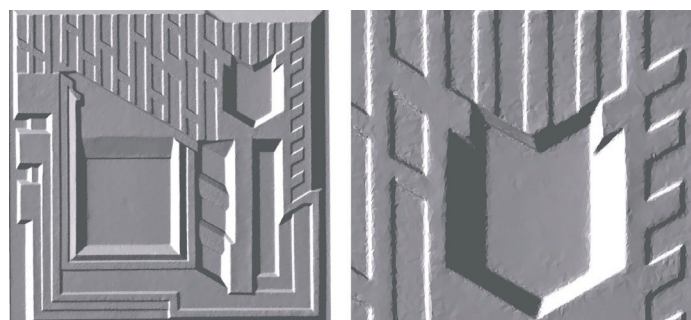
The unique geometry of the Frank Lloyd Wright textile block design includes many primary areas of essentially planar geometry contrasted with other areas of fine detail, sharp corners and filleting. The digital model immediately revealed inadequacies in the decimation software as it was not able to accommodate the combination of the sometimes highly configured areas with the areas of plain geometry. Either the detail was well-captured and the file size became too high in the simple geometry areas, or the file size was manageable but the fine detail was lost. The problem was accentuated by the original condition of the aluminum mold that was scanned. The mold had been previously used to physically create numerous textile blocks. In doing so, it has been slightly damaged, actually subtly pitted from the construction process. The digital camera scan was picking up these irregular features, and the decimation software was not able to resolve the complexity (to a more simple model) of the digital model in a satisfactory manner. Fig 4 – Digital image of scanned mold; note that it is a mirror image of the original

The file had to be simplified for three reasons: we did not want to duplicate the pitting on the new blocks, the file size was much too large for our fabricator to handle, and the fabricator was afraid that his machinery (he was donating the time on his CAD/CAM machine) would take a tedious amount of time slowly milling the aluminum

billet as it reproduced all the pits and irregularity on the surface. Different solutions were proposed including asking the fabricator to essentially turn down the resolution on his machine; this was unworkable because then the sharp edges of the original textile block design would be lost. We are currently working on some of the other solutions: trying different versions of software to decimate the mesh (a more intelligent software program would help), paying a person to edit the file to clean it up (not exactly what we had in mind when we started the project!), or rescanning a newer version of the mold (it has other warping problems so this will probably not work). If all else fails, we could use other techniques to make an aluminum copy of the existing mold, but one of the goals of the original project was to demonstrate the usefulness (and ease!) of CAD/CAM techniques.
