## Research on Mechanism of Overturning Failure for Single-column Pier Bridge

### ABSTRACT

## COLLAPSE INVESTIGATION OF CHUNHBUI BRIDGE

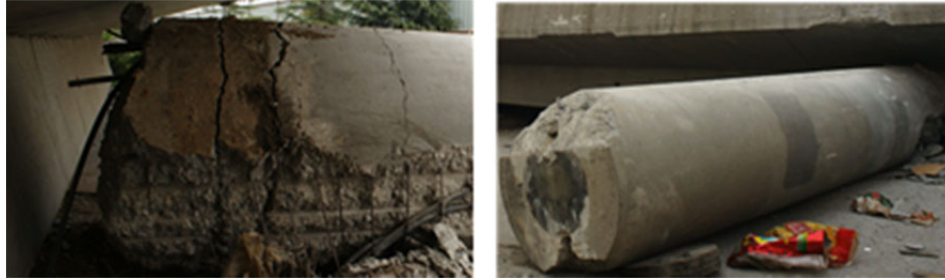
**Field Investigation.** Through the analysis of collapsed wreckage, the pier failure suggests mainly compression and bending type dominated by bending type. From the pier 2 to pier 6, the top of piers all have 42-48° punching shear failure plane. As shown in Figure 2.

**Figure 2 Failure pattern of pier at collapse scene**

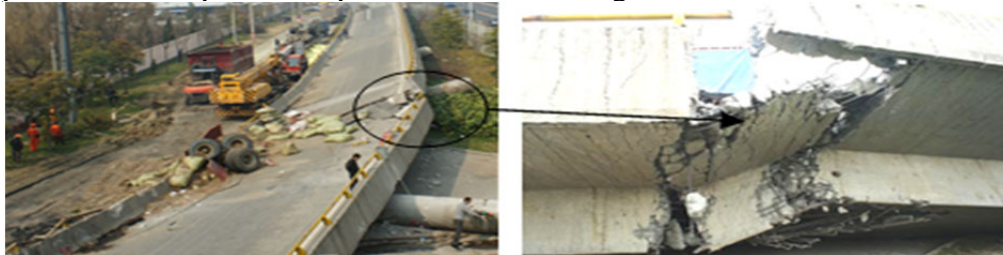
At the scene of the Chunhui bridge collapsed, there is an obvious damage happened between pier 5 and pier 6, as shown in Figure 4.

**Figure 4. The failure pattern of box girder at collapse scene**

There are two possible reasons of box girder destruction as follows: one is after the bridge pier collapsed, the box girder has curved destruction in place of overload vehicle, as shown in Figure 5. Another is in the falling process of box girder, because the box girder on higher pier takes longer time to fall, and have larger horizontal displacement, after the box girder on lower pier is landed, the ground has constraints on box girder, but the box girder on higher pier is still falling, and the

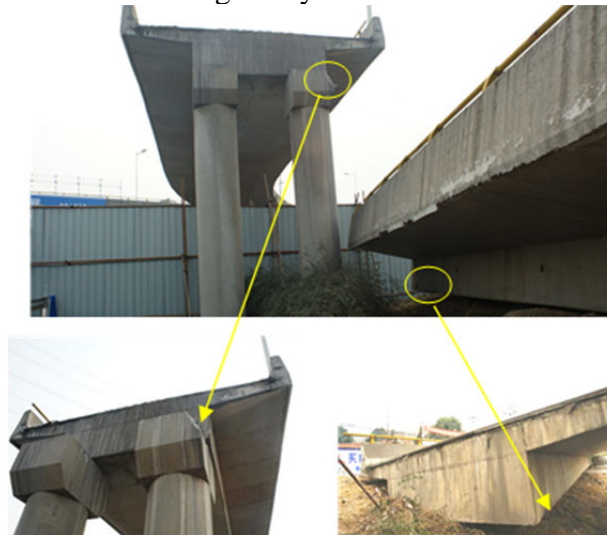
As can be seen from the Figure7, when box girder collapse occurs, box girder and pier contact. Through the analysis of the contact traces, we can find the mainly movement trend is that the box girder rotates along a horizontal axis, and moves along the longitudinal axis of the bridge if the ends have no curved destruction. Therefore, we can confirm that the upper structure has no huge curved destruction before the pier collapse, and keep intact before overturning. Subsequent paper will focus on the superstructure overturning firstly.

**Figure 7. Wreckage collision traces of box girder at collapse scene**
